Mobile Intel[®] Pentium[®] II Processor Specification Update

Release Date: October 2002

Order Number: 243887-045

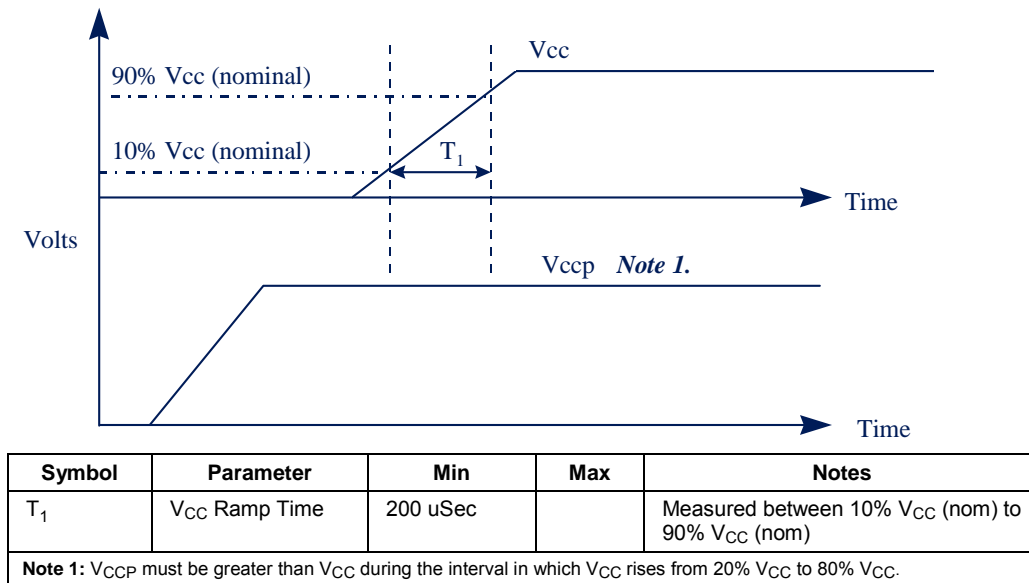
Figure 1. V_{CC}/V_{CCP} Timing Requirements (Mobile)

Problem: The processor uses the PWRGOOD signal to ensure that no voltage sequencing issues arise; no pin assertions should cause the processor to change its behavior until this signal is asserted, when all power supplies and clocks to the processor are valid and stable. However, if V_{CC} ramps up before V_{CCP} , it will cause the processor to enter an invalid state.

Implication: If this erratum occurs, the system may boot normally however, the L2 cache may not be initialized.

Workaround: For Mobile Pentium II processors, ensure that V_{CC} ramps after or with the L2 cache IO voltage (V_{CCP}). If V_{CCP} ramps after the V_{CC} , a delay circuit can be placed on the core V_{CC} to ensure that V_{CC} ramps at the same time or after V_{CCP} as shown below in Figure 1.

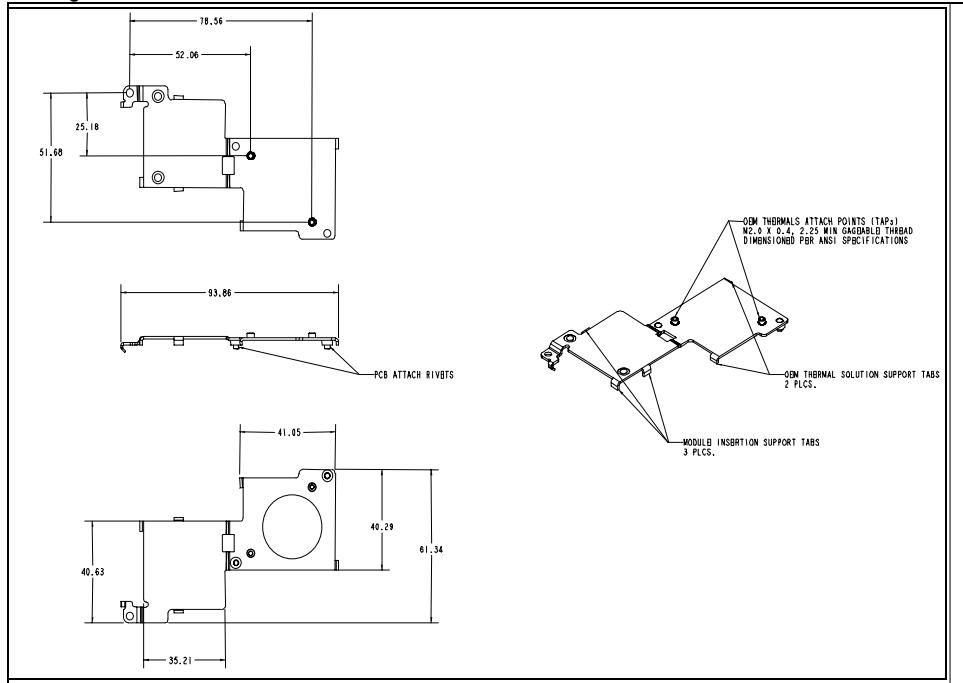
Figure 1. TAP Gageable Thread Clarification

OEM Thermal Attach Points (TAPs) M2.0 x 0.4, 2.25 min gageable thread dimensioned per ANSI specification.

See Figure 1 below for more information.
